Investigating the Causes for Failures in Construction by Taking a Case Study

3. CASE STUDY -KHED BUILDING COLLAPSE

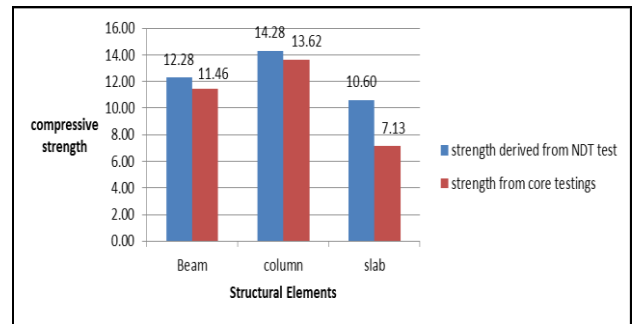
Fig 1 compressive strength vs structural elements

Comparison of strength of NDT test and core testing results				
Elements	Strength derived from NDT test	Strength from core testings	Difference	% variation
Beam	12.28	11.46	0.82	6.71
Column	14.28	13.62	0.66	4.62
Slab	10.60	7.13	3.47	32.74

- II. The concrete mix used was M20 but the strength obtained from rebound hammer test and core test were 12.94 N/mm² and 10.73 N/mm² which is very less as compared to what the required should be.

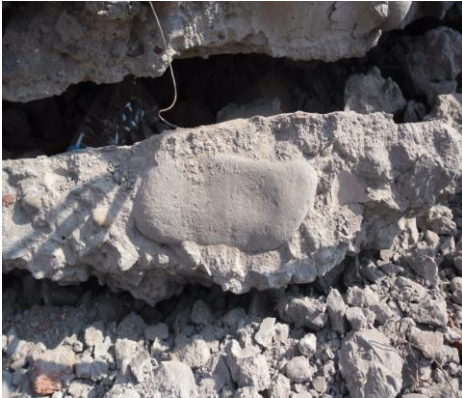
Fig 2 Presence of Cobbles In Concrete

- V. There was use of cobbles in manufacturing of concrete which can be clearly seen in the photographs below.
- VI. There were no standard practices adopted on site such as sufficient curing times, sieve analysis, etc. from the presence of cobbles in the concrete.

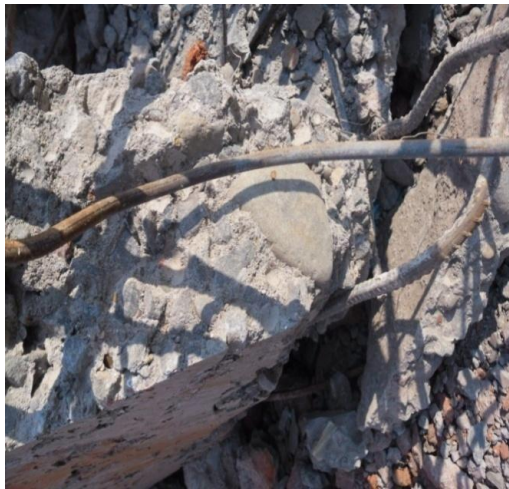
Fig 3 Presence of cobbles and boulders in concrete of beam

- VII. There was no use of vibrators on site at the time of construction of building resulting into poor column and beam joints.
- VIII. Thus it is observed that this failure is caused due to lack of proper inspection and poor workmanship.

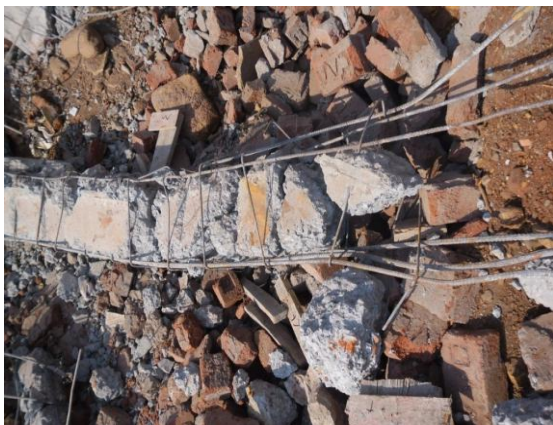
Fig 4 Destruction of concrete can be seen

- I. There was use of stone grit in place of sand for making of concrete. The building was collapsed entirely.
- II. There was complete failure of concrete seen on site as the ingredients of concrete were separated and concrete was crushed entirely. This clearly indicated that proper concreting practices were not performed on site.
- III. There was also presence of cobbles for manufacturing of concrete which could be clearly seen in the photograph below.
- IV. This also clearly indicated that proper sieve analysis was not done for design mix which ultimately resulted into poor concrete.
- V. From informal sources it was known that insufficient curing time was also one of the reasons for collapse.
